AIAA 98-3923

**Microfabricated Ion Accelerator Grid Design Issues:
Electric Breakdown Characteristics of Silicon Dioxide
Insulator Material**

**34th AIAA/ASME/SAE/ASEE
Joint Propulsion Conference & Exhibit
July 13-15, 1998 / Cleveland, OH**

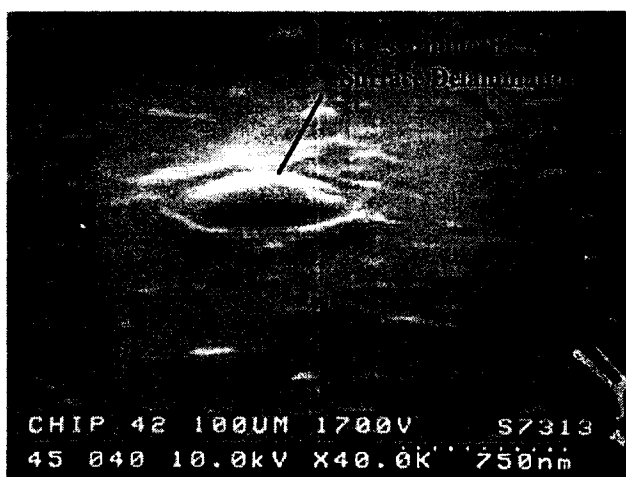
Fig. 28: Example of Stress-Induced Surface Delamination (less than 1 μm dia.) on Oxide.

Therefore, it was concluded that surface morphology of the type observed in Figs. 27 and 28 did not affect breakdown strengths. This is an important find, in particular with respect to ion engine accelerator grid applications, where sputter erosion may lead to surface roughening. However, it should be pointed out that the particular surface features encountered here have relatively smooth shapes and comparably large radii of curvature compared with the intrinsic silicon oxide surface roughness as observed in Figs. 27 and 28.
